PRIMARY RECORD

Page 1 of 3 *Resource Name or # (Assigned by recorder): Campbell House

c. Address: 684 South 2nd St. City San Jose Zip 95112

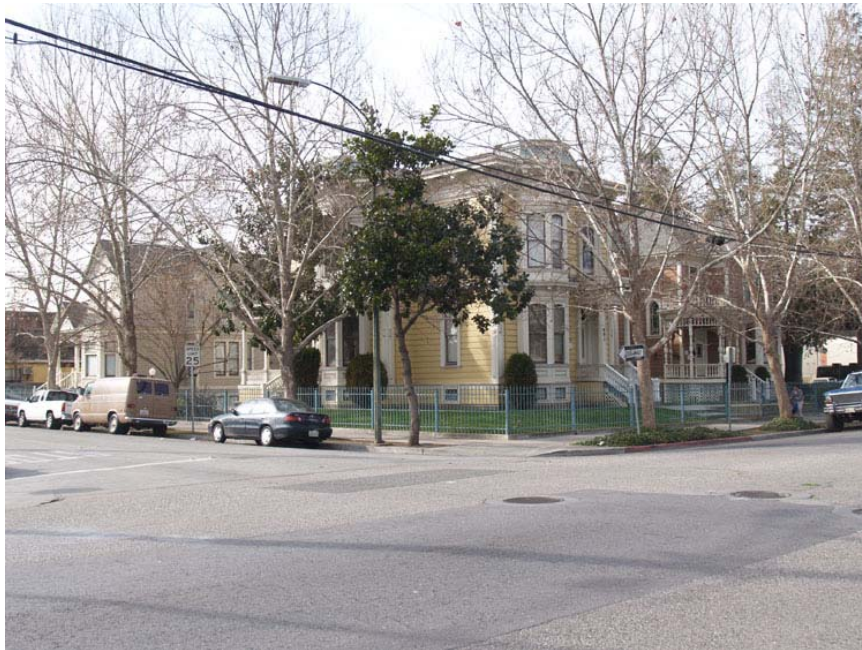
The house is trimmed by flat-boards at the corners, a dentilled frieze board under the eaves, and a watercourse band at the main floor level. Entry is through a front-gabled porch supported by tapered square columns. The porch pediment has an unusual diagonal shingle pattern that is broken up by a simple arrangement of flat boards in a square. The front door is slightly recessed into the wall; the flush door is a replacement. Fenestration generally consists of 1/1, double-hung windows; the bay window front has a single picture window with a 1-lite transom. The setting includes a modest-size front yard surrounded by a low concrete curb at the sidewalk; a modern wrought-iron fence surrounds the property. The parcel is directly south of Interstate Highway 280, elevated at this location.

P5b. Description of Photo:
(View, date, accession #)
View facing northwest, 3/06

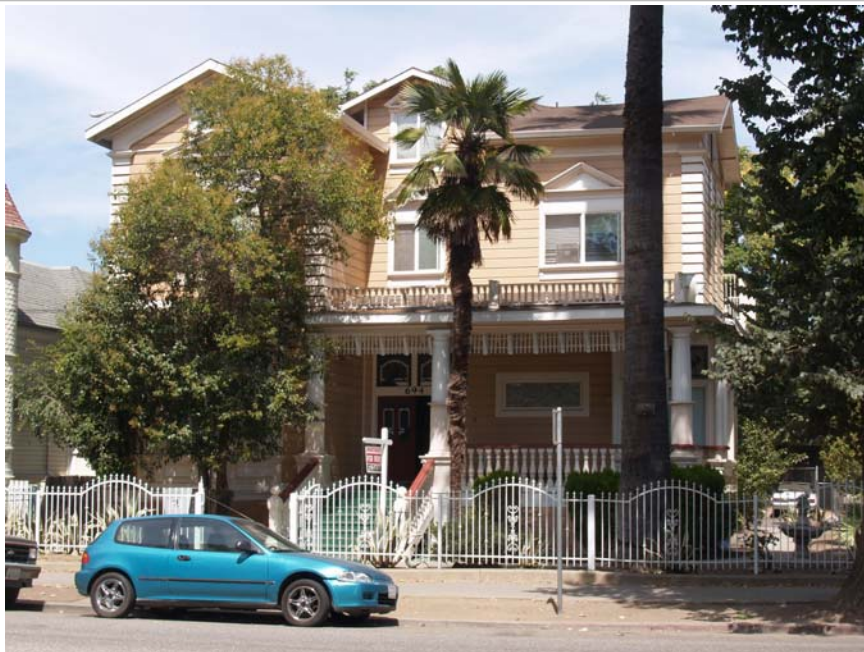
This west-facing, two-story corner house is Italianate in style with some unusual Neo-Classical influences and some recent modifications. It has a raised, asymmetrical, roughly square main mass covered by a complex, moderately low-slope roof that includes a small two-and-one-half-story dormer that may have been added. Atypical for the style, so possibly modified, the house eaves are moderate in depth and open, not boxed; they have added metal gutters. The channel-rustic siding is trimmed by quoins at the corners. A distinguishing feature of the house is the wide frieze band that follows the pitch of the gables; they are slightly curved at the lower corners where they meet the quoins. The residence is accented by its prominent one-story front porch and two small bay windows. A front-facing gable tops a two-story projecting wing that extends into a one-story angled bay window at its base. The bay window includes raised paneling below the windows. The second distinctive bay window is a square, corner bay at the first floor; it cantilevers atop a series of jigsaw brackets and features stained glass transoms and round corner posts. Fenestration on the front and sides of the house includes a variety of forms and sizes of windows; most of the sash has been replaced by vinyl windows and aluminum sliders, but the casings appear original. The window and door trim consists of flat boards; to the north side, the windows have a deep cantilevered hoods. To the south side (facing Margaret Street), the second-story has no windows, but it features intermediate quoins, so window(s) may have been removed.

The wide projecting porch features a very low slope hipped roof trimmed to look like a balcony. The roof is supported by heavy Tuscan columns that are fluted from their bases to an intermediate trim ring at just beneath half their height. The columns are set on low, almost cubical, pedestals. The current balustrade is taller than the pedestals and higher than the adjacent window sill and appears to be a replacement; it consists of heavy turned balusters and a heavy cap rail. An unusual series of pickets and corbels is suspended from the porch ceiling; it acts as a spandrel but is separate from the columns. The double-wide front door is topped by a pair of stained-glass transoms. A second-story balcony faces Margaret Street; it has modern metal railings. The setting includes a modest front and side yard bordered by a low concrete retaining curb and modern wrought-iron fence; access to the rear accessory structures is from an alley.

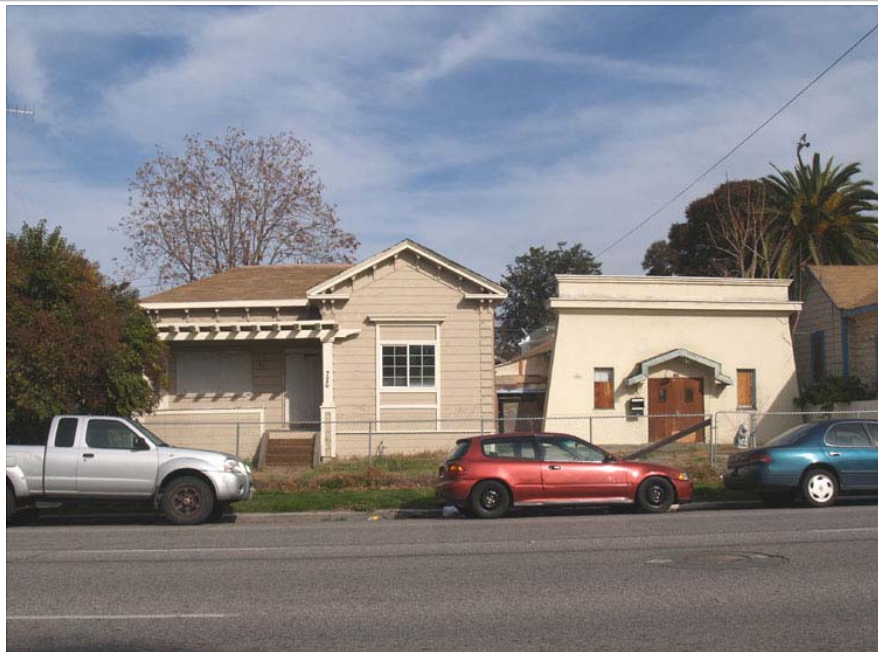
726 South 2nd Street description: This west-facing Italianate house has a slightly raised, one-story main mass topped by a moderately pitched gabled roof. The residence occupies half of the parcel. The recessed porch includes Craftsman detailing with a square column supporting a trellis with flared beams. Special detailing that distinguishes this house includes the eave returns at the gable end and the series of carved Italianate brackets that wrap the main eaves. The house is clad in channel-rustic siding, and the corners are trimmed with raised wood quoins. Fenestration on the house generally consists of new vinyl siding windows which have been inserted into the original window openings and some of the windows are covered over with wood paneling. A brick chimney is located the south side of the house. The setting includes a shallow front yard.

P5b. Description of Photo:
(View, date, accession #)
View facing east, 2/07

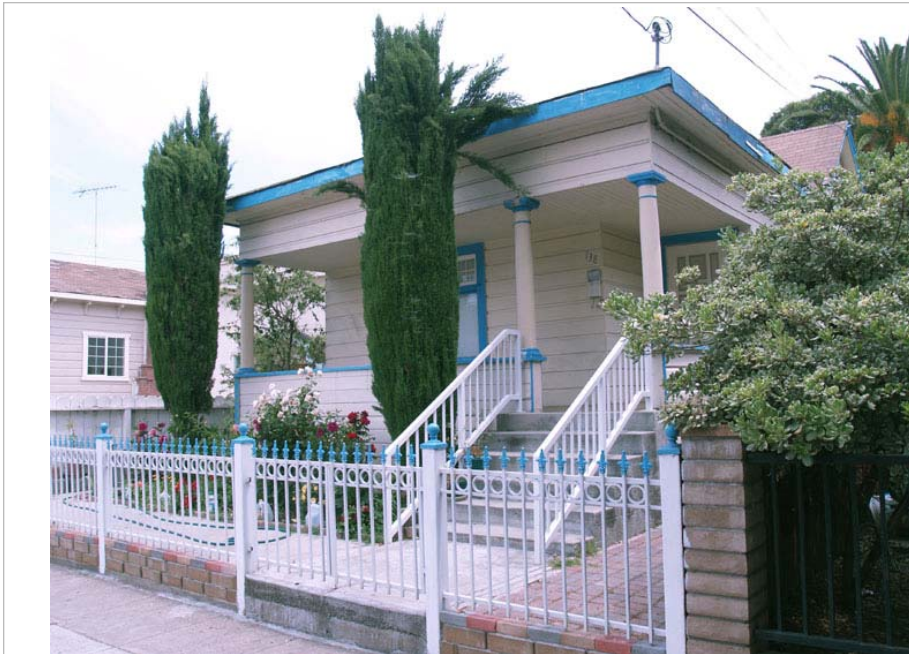
This Neoclassical residence is one story with a side-gabled roof and a projecting flat-roof porch. The roof is covered in composition roofing and the roof has slightly overhanging boxed eaves. The main mass of the house, clad in channel rustic siding, has a rectangular footprint with a full-width front porch. Tuscan columns sit on the low, solid porch railing which is covered by channel rustic siding. A wood paneled front door is located on the south side of the porch. Fenestration includes large fixed windows with multi-lite transom windows and 1/1 double-hung wood windows. The front porch is accessed by replacement concrete steps with a new metal railing.

P5b. Description of Photo:
(View, date, accession #)
View facing north, 5/06

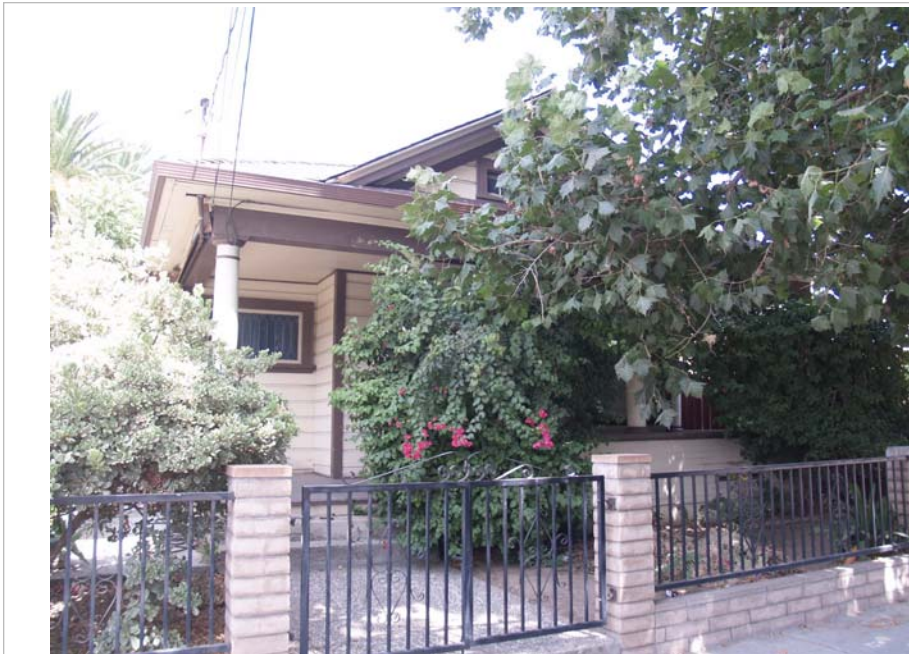
This Neoclassical residence is one-story in height and has a rectangular footprint. The building is topped by a hipped roof with small front facing gable in the center of the roof. The roof is covered with composition shingles and has overhanging boxed eaves. The walls are covered with channel rustic wood siding. A large wrap-around porch on the front facade is approached by a set of concrete steps. The porch is supported by Tuscan columns which rest on a solid balustrade covered with wood siding. A new paneled wood door is located on the front porch. Fenestration consists of 1/1 double-hung windows, a fixed leaded window in a lozenge pattern on the front porch and a multi-lite horizontal window in the centered gable. All windows have wood frames and sash.

P5b. Description of Photo:
(View, date, accession #)
View facing northeast, 3/06

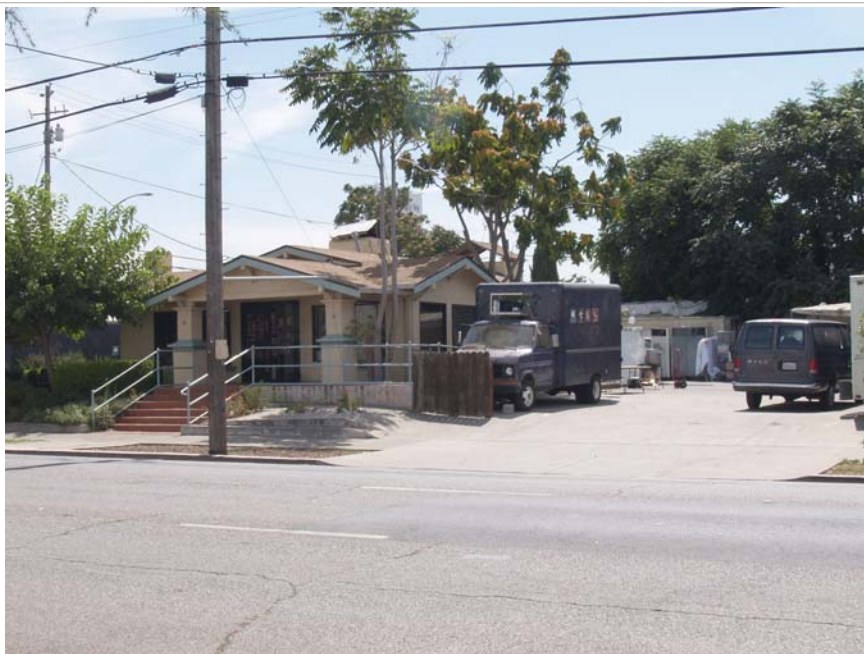
This east-facing Craftsman-style bungalow, on its corner parcel, has been modified over time with replacement windows and a series of additions to the rear; it is now used as a commercial catering kitchen. The stucco house has a slightly raised, one-story, slightly "H"-shaped original main mass with a low-pitched gabled roof. A gable projects to the front over a deep entry porch, and a dormer-like gable rises above the cross ridge. The main gables are each supported on three cantilevered outlooker beams (one at the ridge and one each at the eaves). The front porch gable is supported on knee braces. Multiple, gabled, additions extend to the rear (west), and large chimneys project from the roofs, both original and new. As common for houses of this style, the eaves are deep and have exposed rafter tails. Entry to the house is through a wide porch with wide, red-tiled stairs and pipe railings for handrails. The porch roof is supported massive square columns with wide pedestals and tapered upper sections. The solid railing is low and clad in stucco. The front door and all fenestration have been replaced with anodized aluminum units; some have faux muntins. The setting includes a modest-size front yard and very narrow side yard surrounded by a low concrete retaining wall at the sidewalk. The rear and sides of the parcel have been paved for commercial use.
